Myanmar - Cyclone "Nargis" - Flood Extent May 14, 2008 - Sheet 2: Yangon City

1:50,000

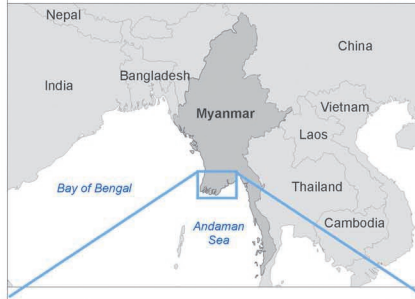
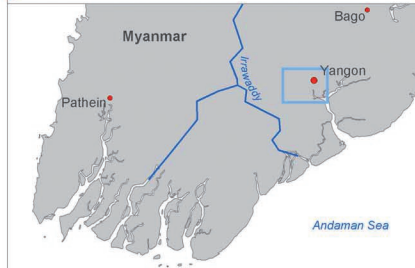
On May 9th a first analysis of the flood situation derived from TerraSAR-X data acquired on May 6th was generated. This second analysis shows the inundated areas derived from TerraSAR-X radar satellite imagery of May 14th and the pre-disaster water level derived from LANDSAT-7 ETM of November 7th, 2000 around Yangon capital.

Due to heavy rainfall the water level did not change significantly within the 8 days between both images. As mentioned for the first analysis inundated areas may also contain regions which were covered by water before the disaster due to the prevalence of wet-rice cultivation. The results are superimposed on LANDSAT-7 ETM imagery of November 7, 2000.

- Derivation of flooded areas from TerraSAR-X
- Derivation of normal water levels from LANDSAT-7 ETM imagery of 2000
- Roads digitized from LANDSAT-7 ETM imagery of 2000
