Myanmar - Cyclone "Nargis" - Flood Extent May 14, 2008 - Sheet 5: Dedaye Region

1:50,000

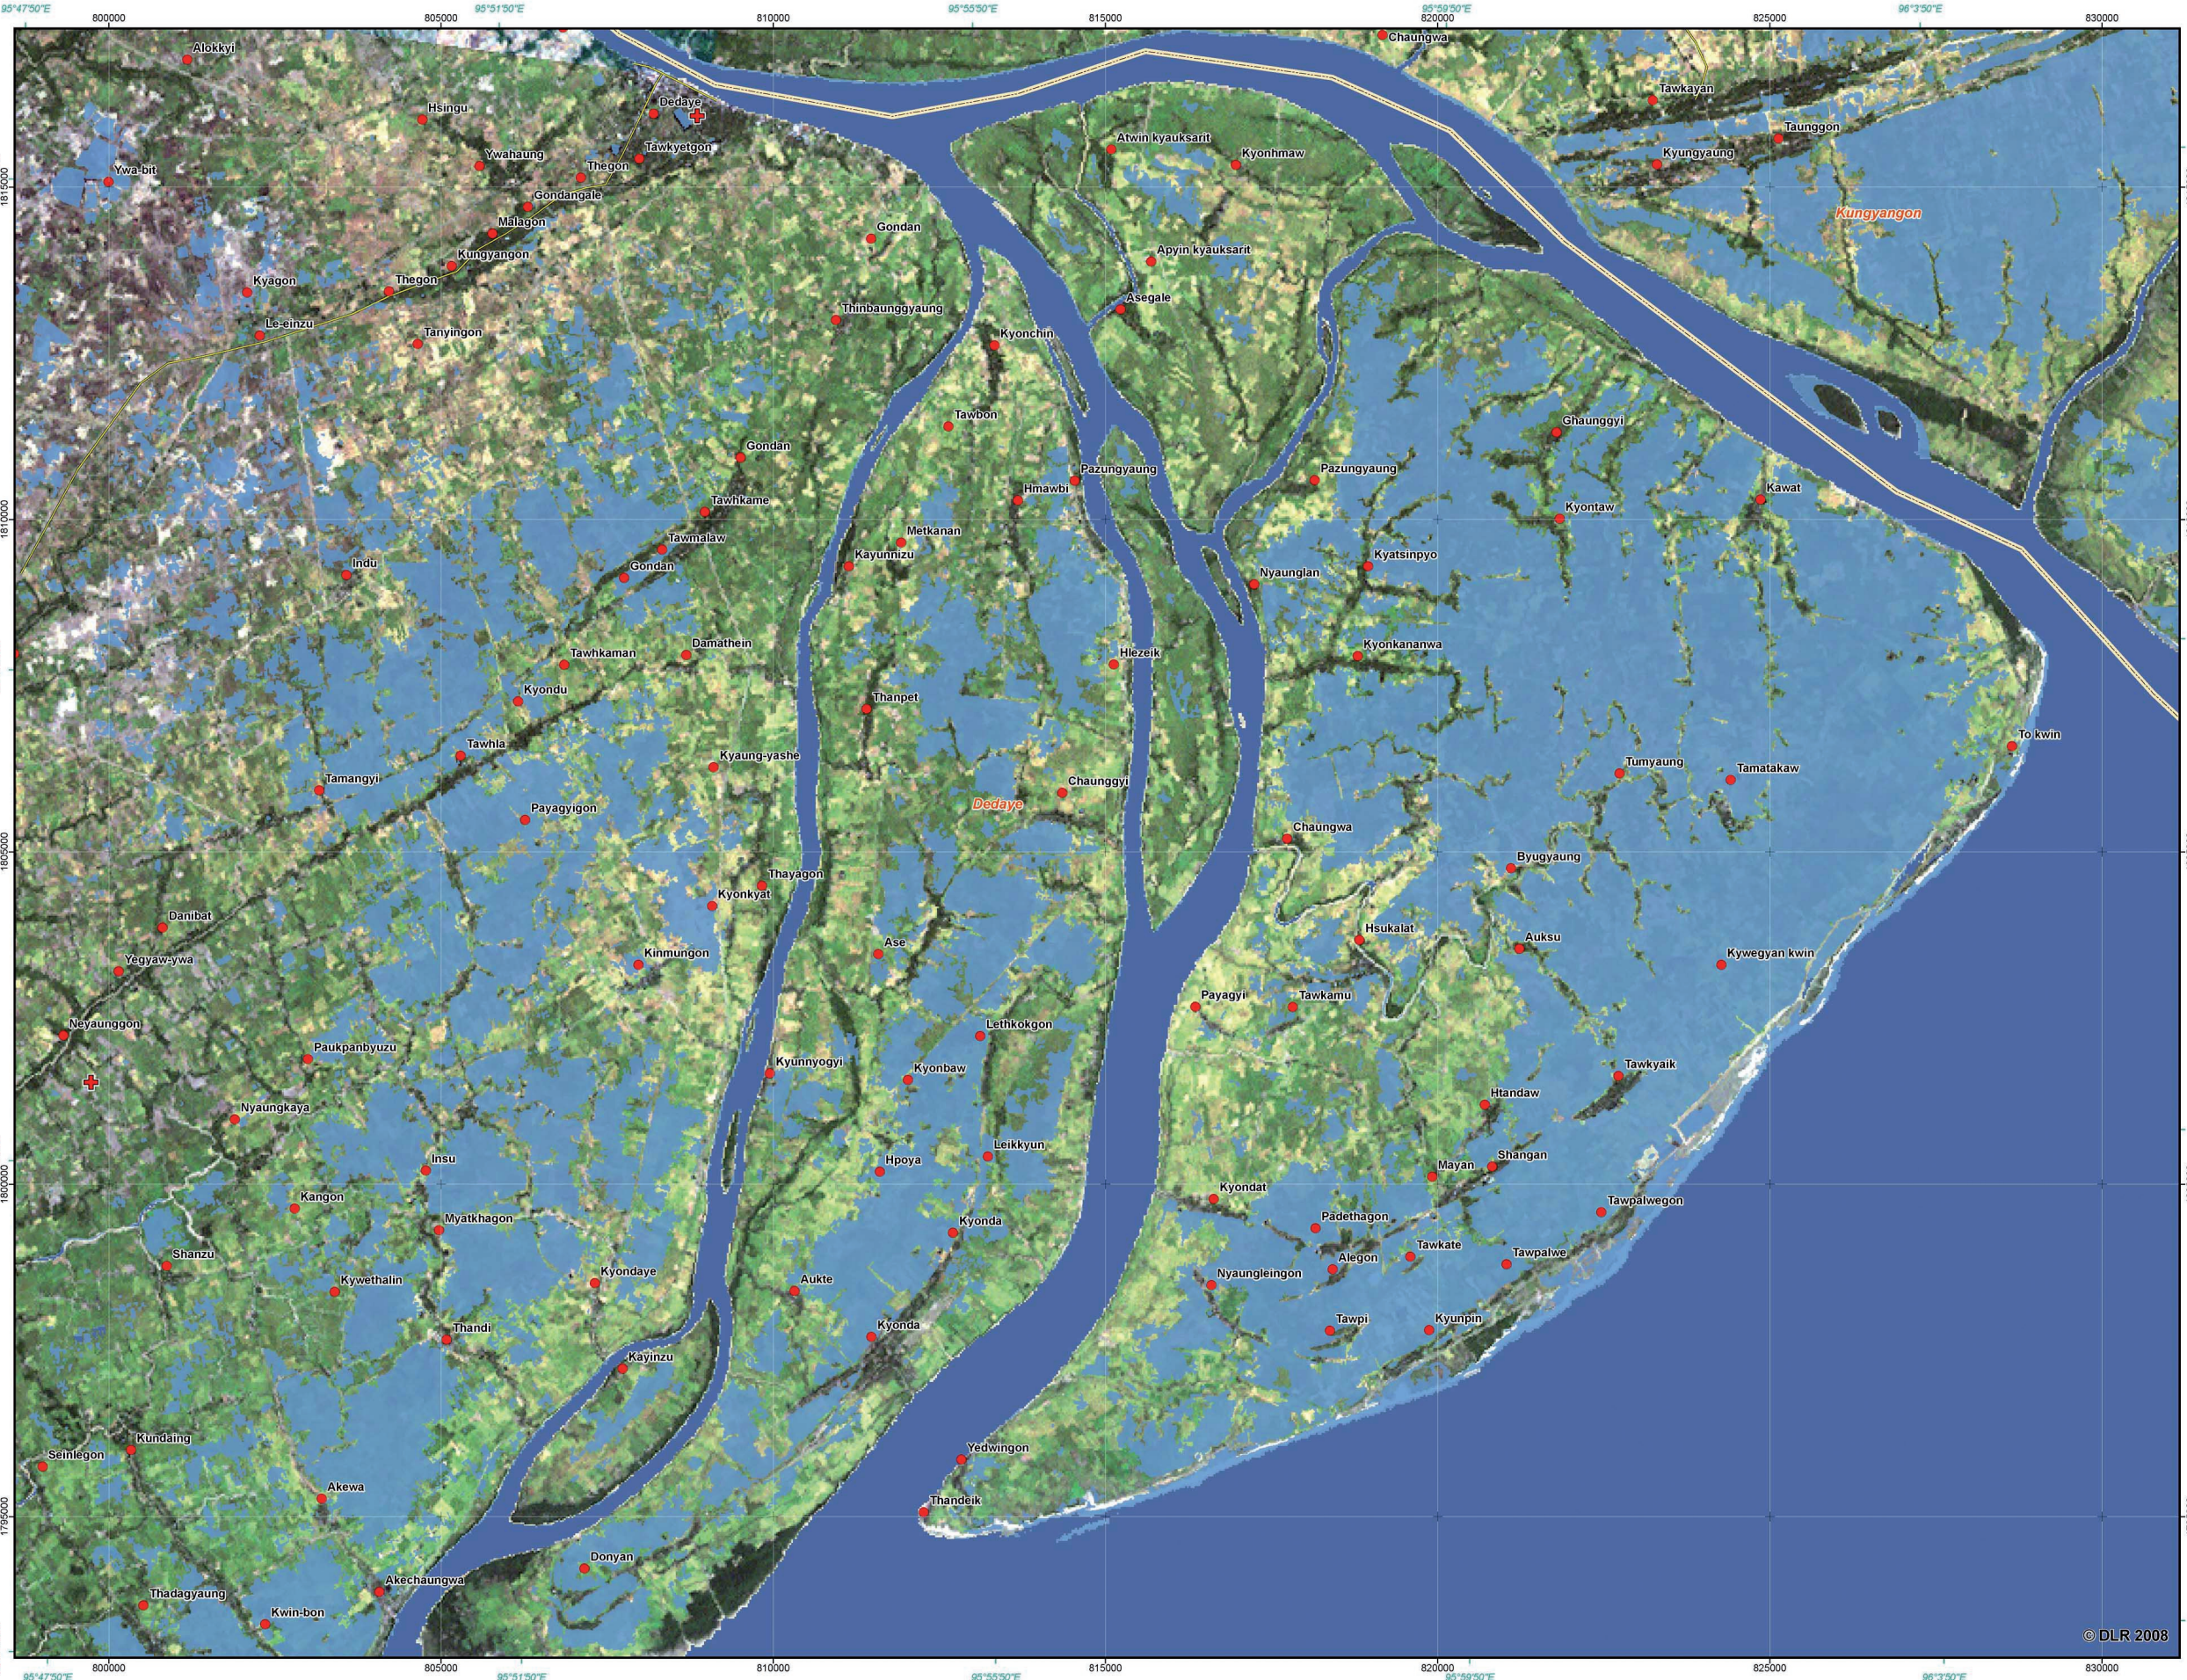
On May 9th a first analysis of the flood situation derived from TerraSAR-X data acquired on May 6th was generated. This second analysis shows the inundated areas derived from TerraSAR-X radar satellite imagery of May 14th and the pre-disaster water level derived from LANDSAT-7 ETM of November 7th, 2000 around Dedaye.

Due to heavy rainfall the water level did not change significantly within the 8 days between both images. As mentioned for the first analysis inundated areas may also contain regions which were covered by water before the disaster due to the prevalence of wet-rice cultivation. The results are superimposed on LANDSAT-7 ETM imagery of November 7, 2000.

- Derivation of flooded areas from TerraSAR-X
- Derivation of normal water levels from LANDSAT-7 ETM imagery of 2000
- Roads digitized from LANDSAT-7 ETM imagery of 2000
