PORTUGAL - Madeira
Flood - Damage Assessment
Curral Das Freiras - Sheet 1
 February 23, 2010
 Scale 1:7,500

Heavy rainfall on February 20, 2010 caused floods and landslides on the Atlantic island of Madeira. At least 48 people were reported dead and 120 injured. The village of Curral das Freiras in the center of the island was isolated for two days due to blocked or damaged roads. Several mudflows and landslides affected vegetation and infrastructure. Furthermore, many roads on the island were destroyed or blocked.

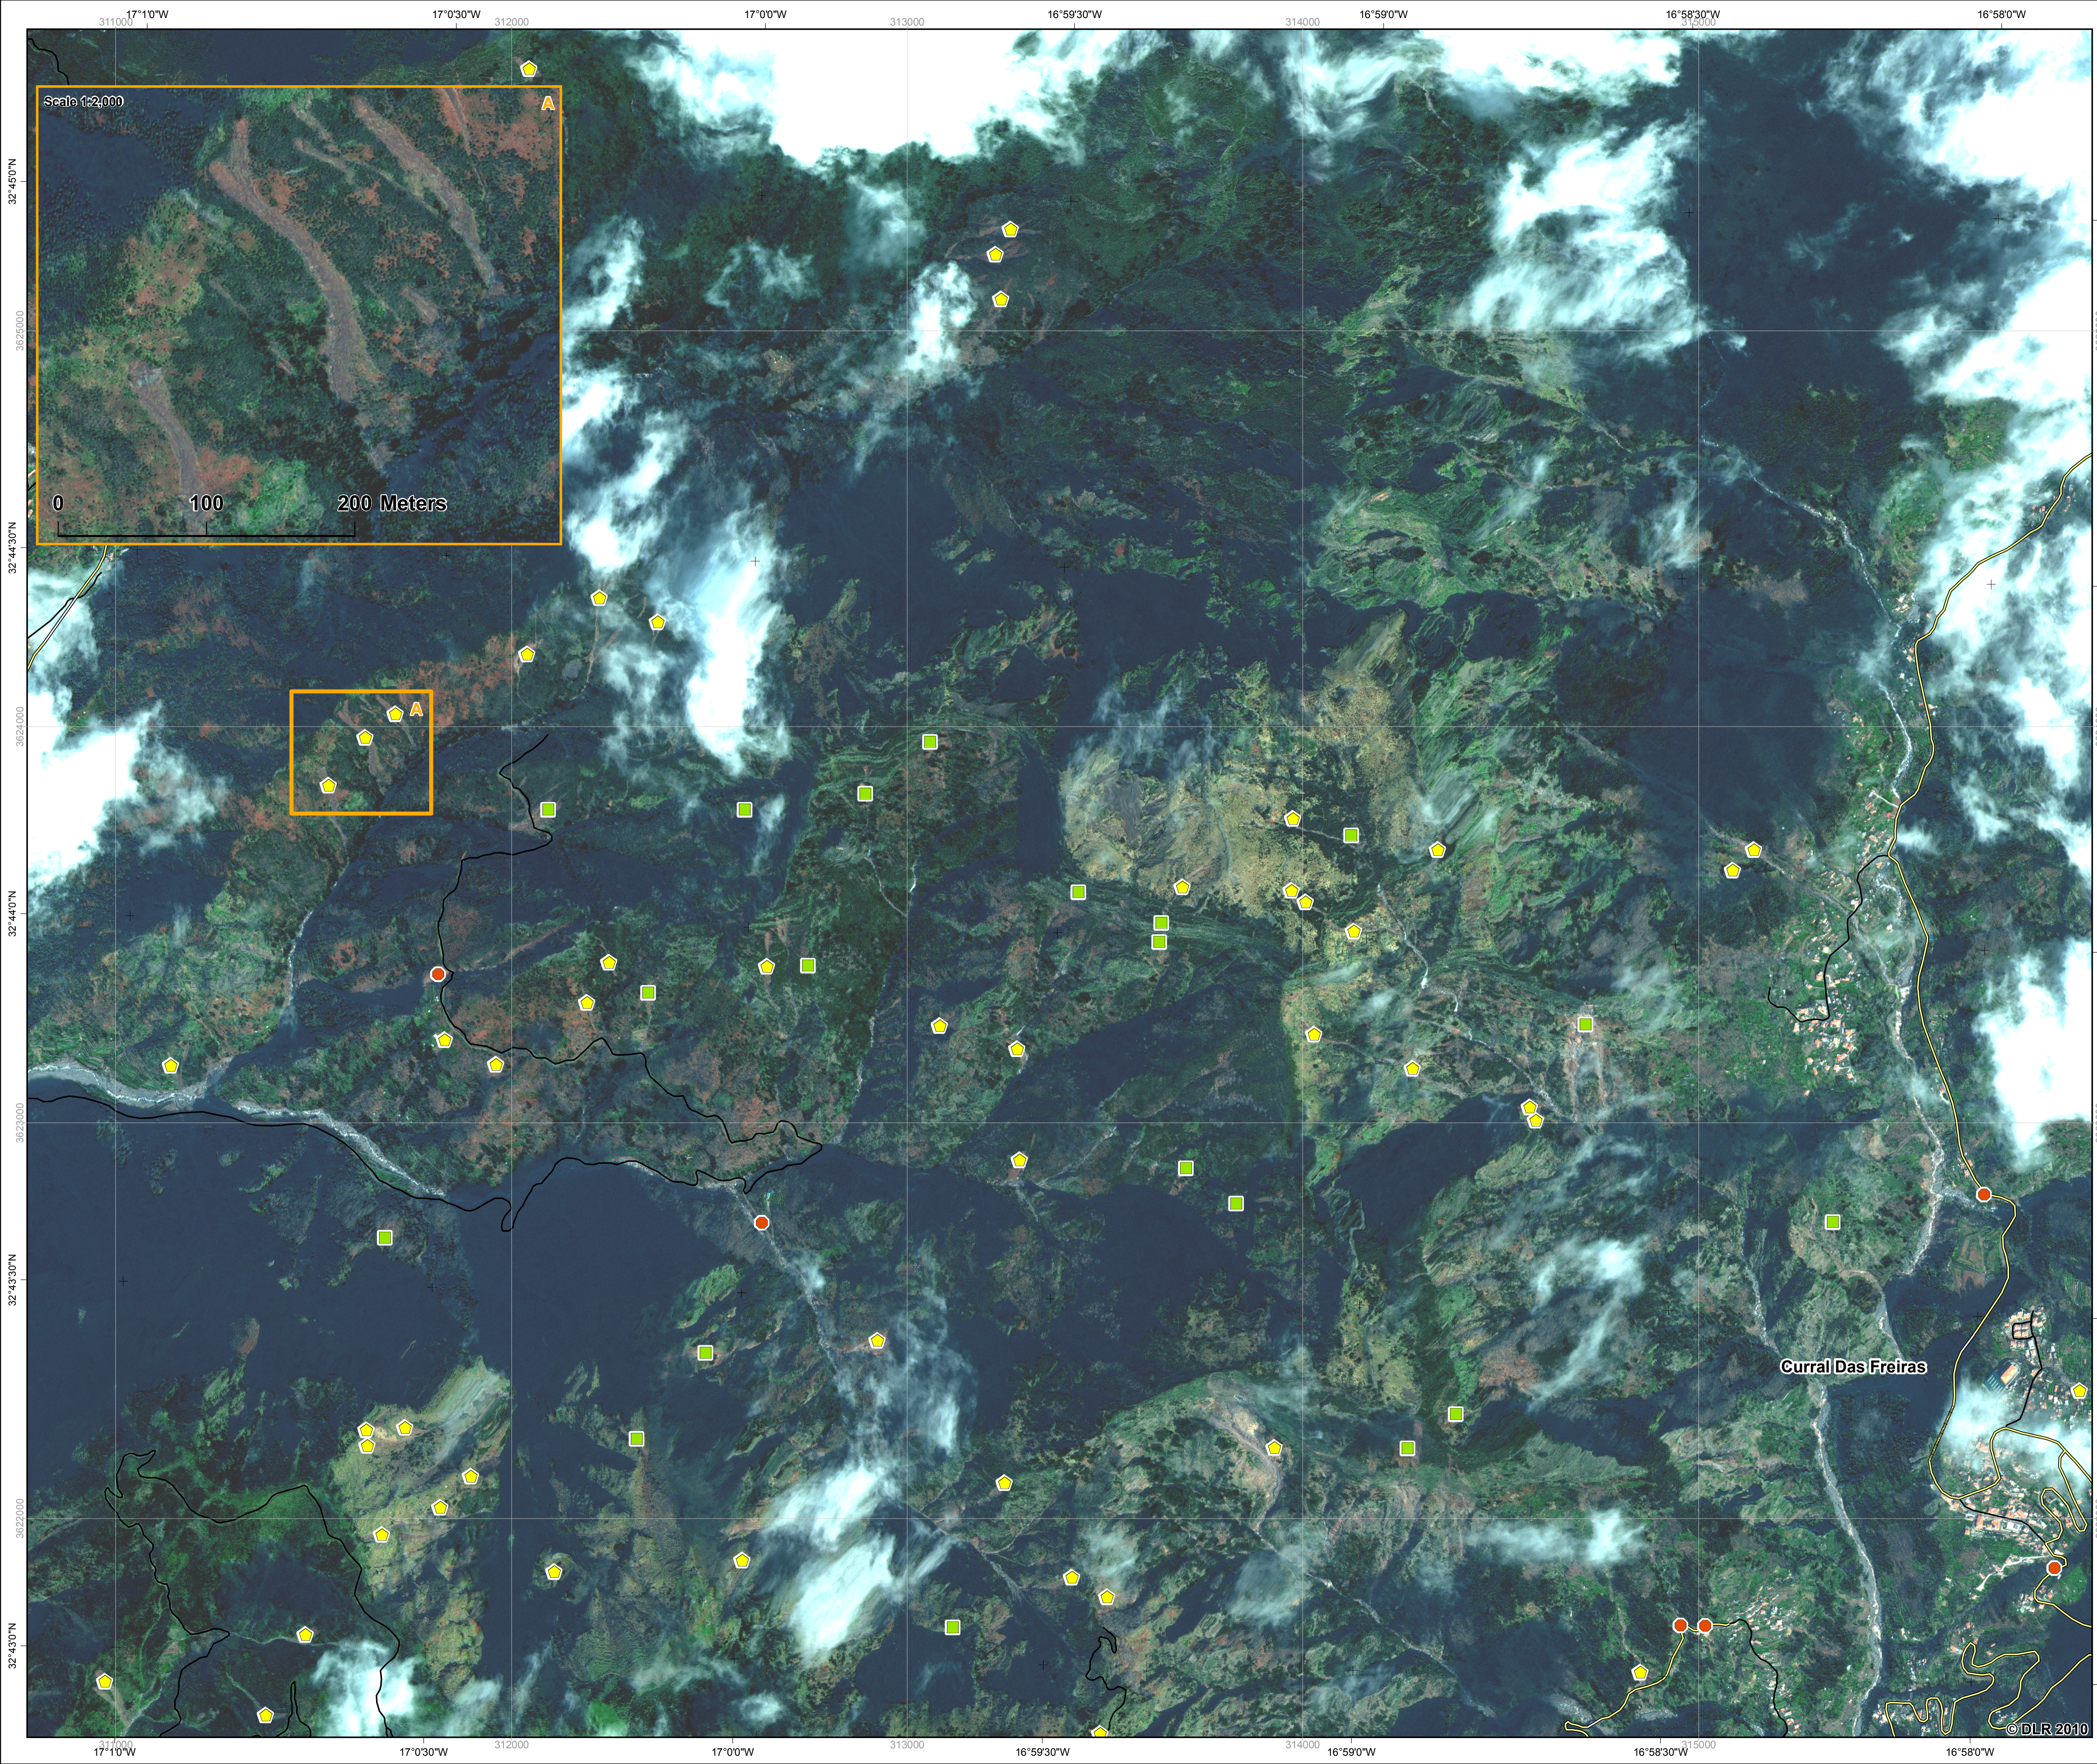
Damage assessment was done through visual interpretation of post-disaster GeoEye-1 imagery acquired on February 23, 2010, and of pre-disaster imagery of the same sensor.

The analysis may differ from actual damages on the ground.
