PORTUGAL - Madeira
Flood - Damage Assessment
Curral Das Freiras - Sheet 4
 February 23, 2010
 Scale 1:7,500

Interpretation

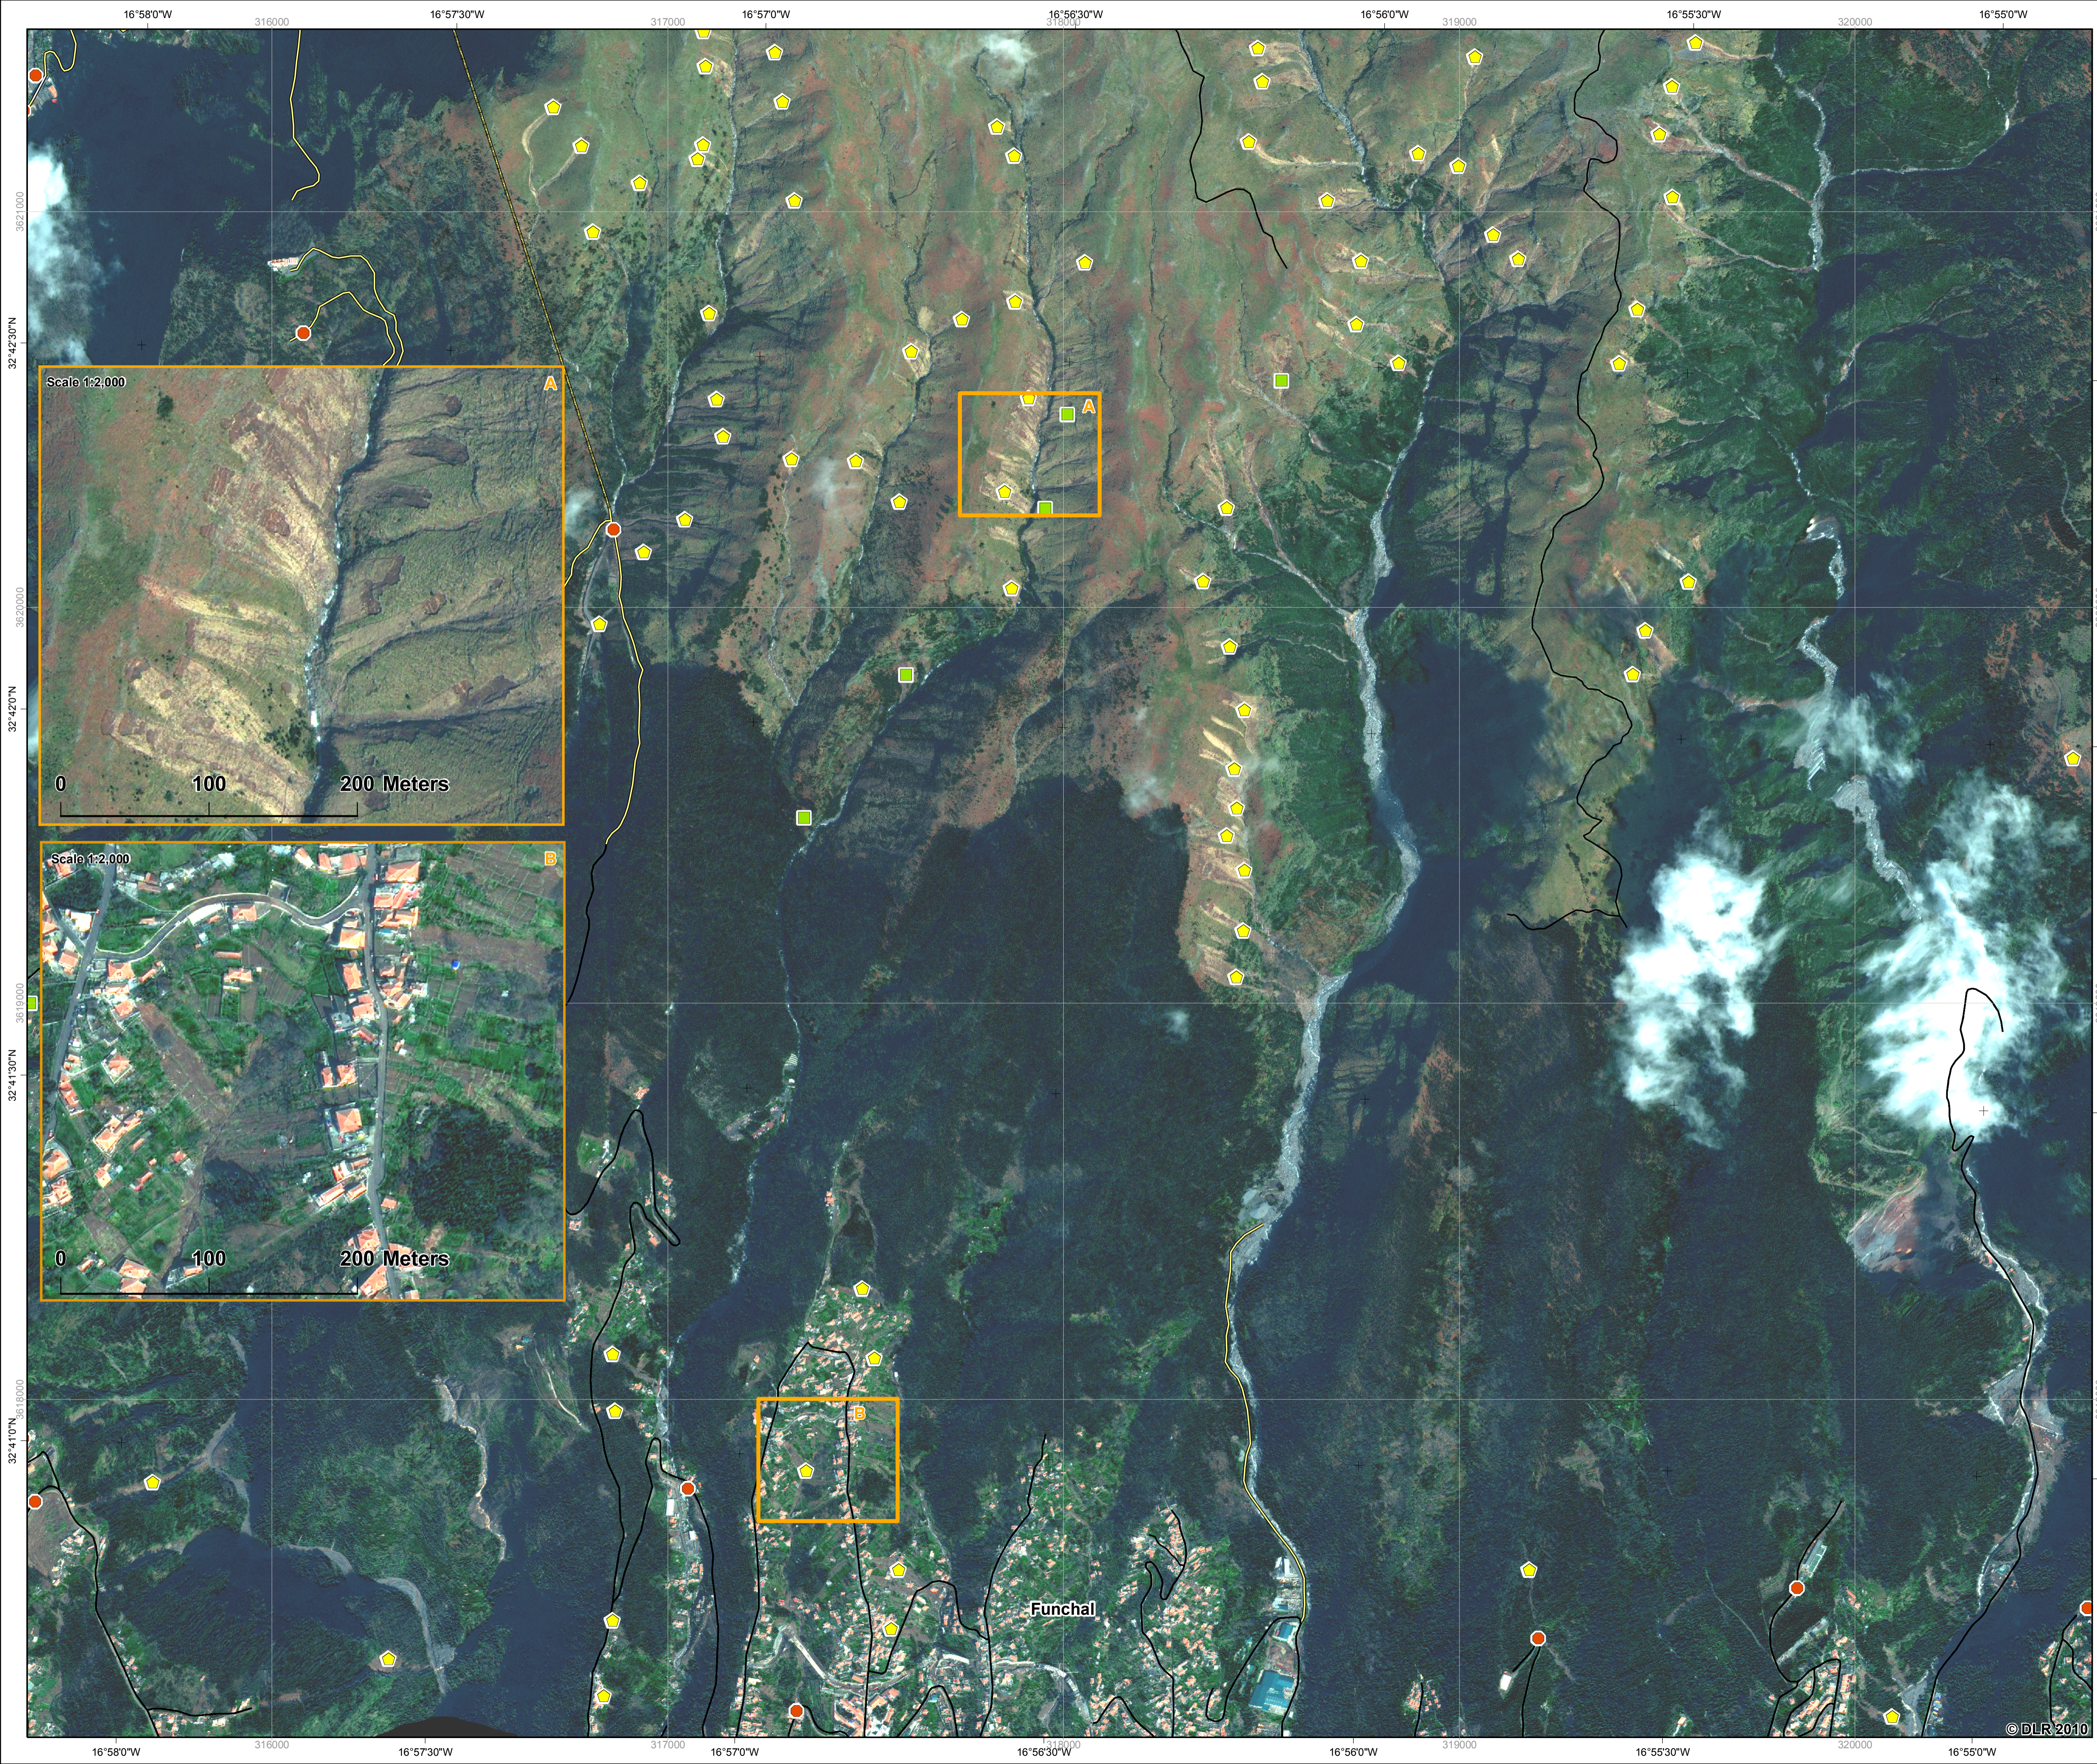
Heavy rainfall on February 20, 2010 caused floods and landslides on the Atlantic island of Madeira. At least 48 people were reported dead and 120 injured. The village of Curral das Freiras in the center of the island was isolated for two days due to blocked or damaged roads. Several mudflows and landslides affected vegetation and infrastructure. Furthermore, many roads on the island were destroyed or blocked.

Damage assessment was done through visual interpretation of post-disaster GeoEye-1 imagery acquired on February 23, 2010, and of pre-disaster imagery of the same sensor.

The analysis may differ from actual damages on the ground.
